PHASE I INSPECTION REPORT
NATIONAL DAM SAFETY PROGRAM

Name of Dam Kagley
County Blount
Stream Unnamed Trib. of
Sixmile Creek
Date of Inspection May 19, 1981

PHASE I INSPECTION REPORT
NATIONAL DAM SAFETY PROGRAM
KAGLEY DAM
BLOUNT COUNTY, TENNESSEE

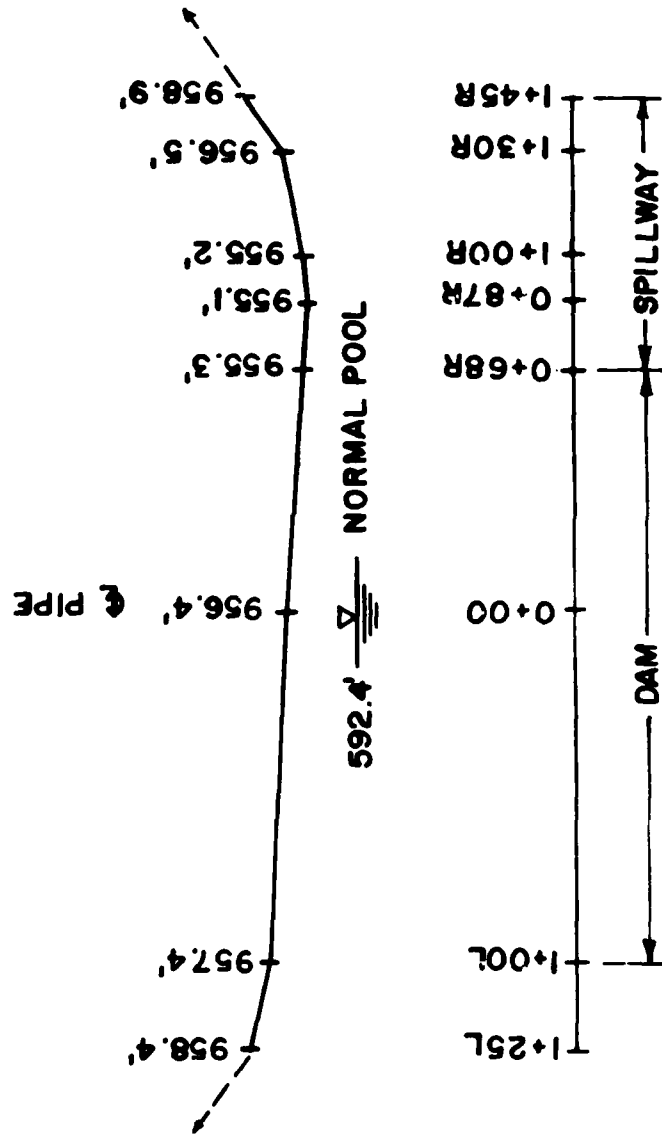
DAM PROFILE
FIGURE 4

end of the dam at the emergency spillway interface (photo no. 9; Figure 4). The upstream face is generally sloped at 3.4H:1V from the crest to the water surface where a small bench has formed from slight wave erosion. The downstream face is generally sloped at 3.5H:1V uniformly across the embankment. All slopes are covered with well maintained grass.
